# SPARC Radiation Tolerant Processor Chip Set (CCA) Design Considerations List

This document describes the current identified specification deviations (as off October 26, 98) for the TSC691E (rev C), TSC692E (rev C) and TSC693E (rev A), with a work around proposal, when available.

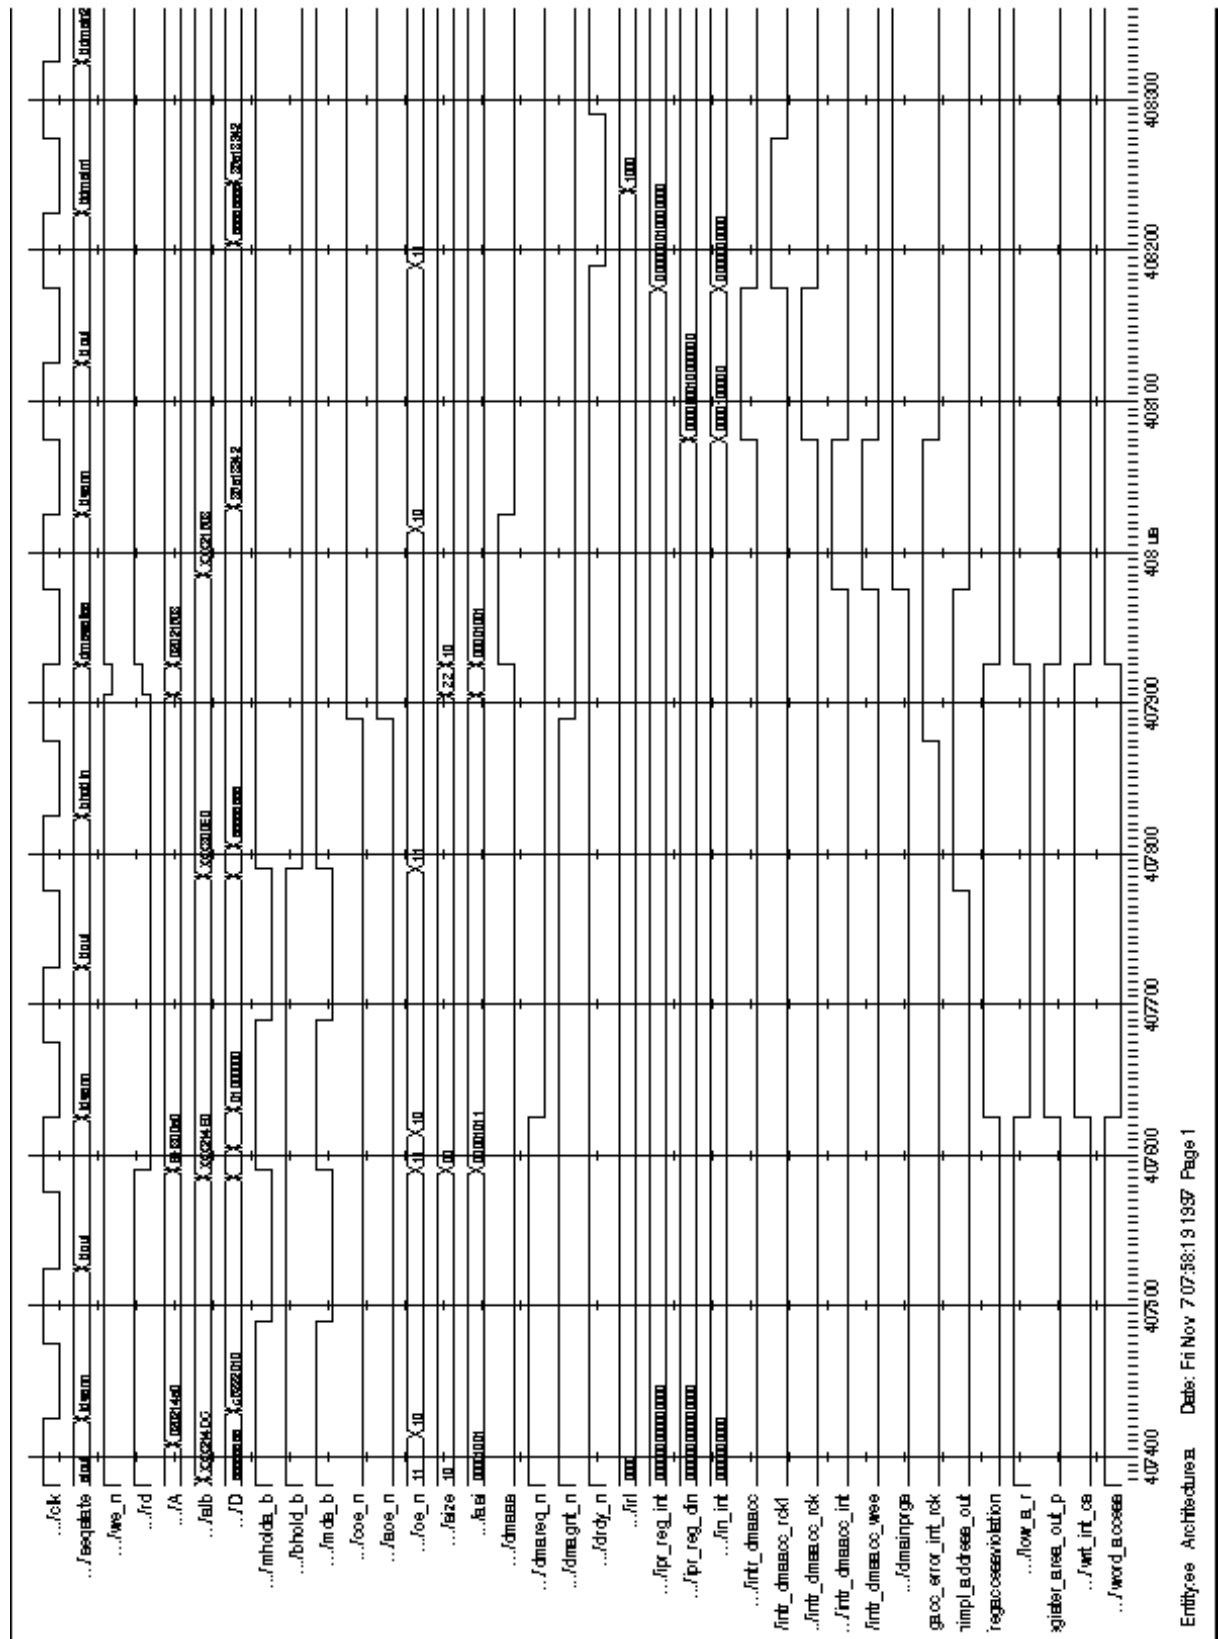
When a DMA access aborts an illegal store byte to a TSC693E register, the TSC693E register access violation leads to a DMA access error: IRL is set to 8.

stb %g0,[%g1 + 0xe0]

with [%g1 + 0xe0] addressing TSC693E UARTA register is aborted as shown on the following timing diagram.

The TSC693E did not record the context in which the register access violation occurred, that is an IU access, and propagated the error through the DMA access context, triggering a DMA access error.

No Workaround known.
